SUBJECT: Research Report 535; "Occurrences of
Expansive Limestone in Kentucky;" KYP-64-13;
HPR-PL-1(15), Part III B.

Research Report
-535-

OCCURRENCES OF EXPANSIVE
LIMESTONE IN KENTUCKY

KYP-64-13 HPR-PL-1(15), Part III B

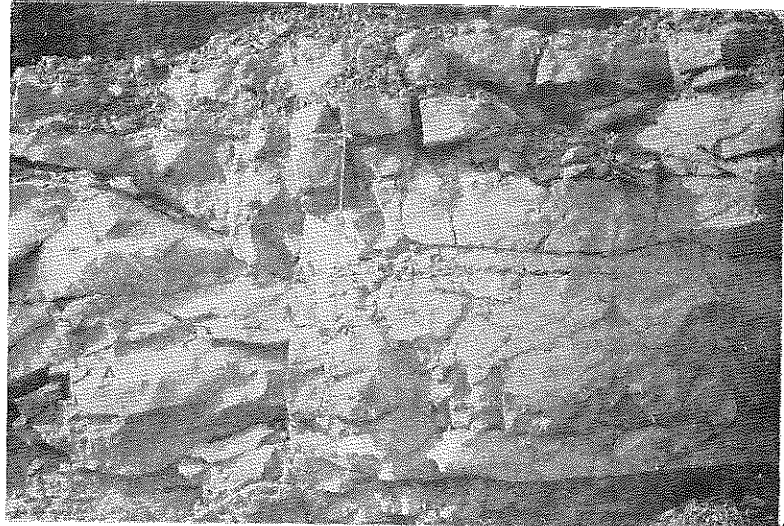
L12B 5'

CLOSE UP HIGHLY
EXPANSIVE LEDGE IN
CONCRETE BEAMS

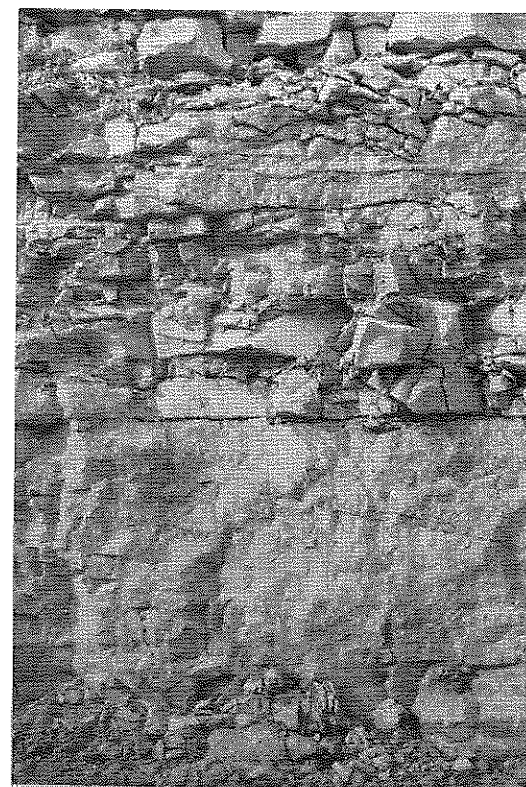
THIS IS NONEXPANSIVE LAYER
SANDWICHED BETWEEN EXPANSIVE
